UM-3727-98
1998 Ford Escort

In-depth Vehicle Occupant Report

The University
of Michigan
Transportation
Research Institute

UM-3727-98

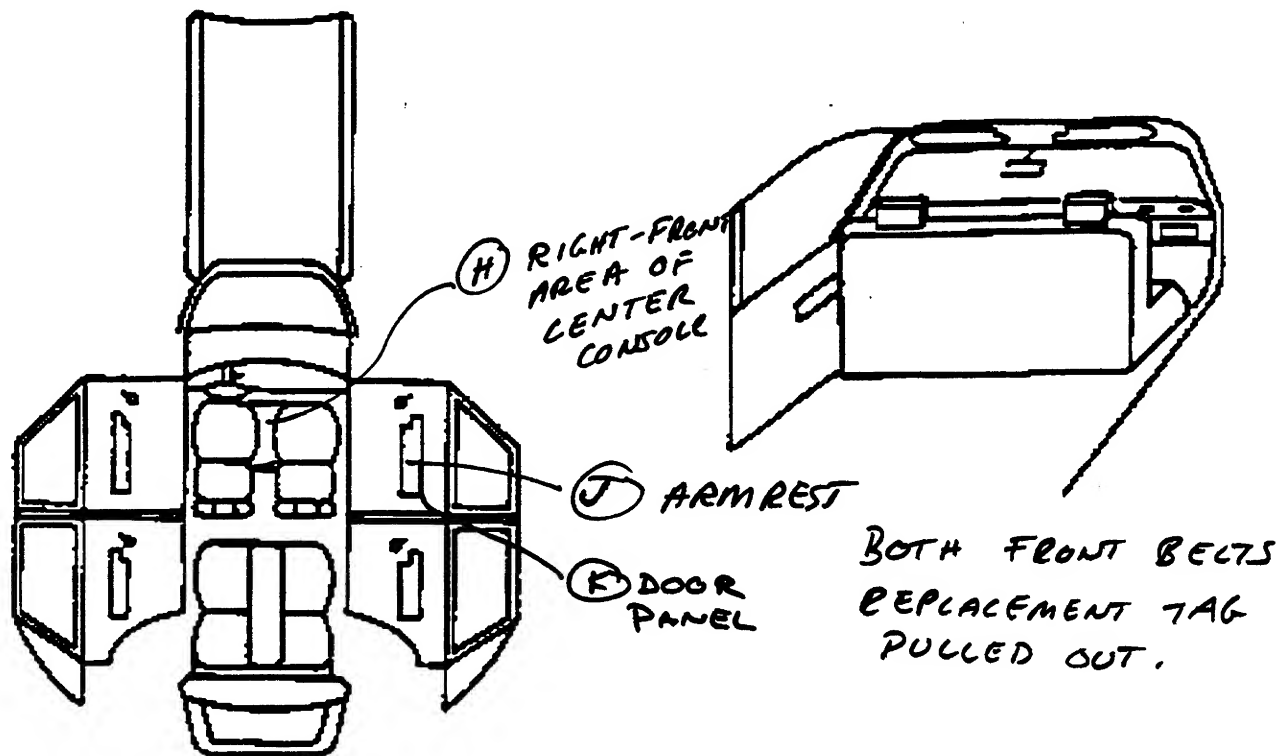
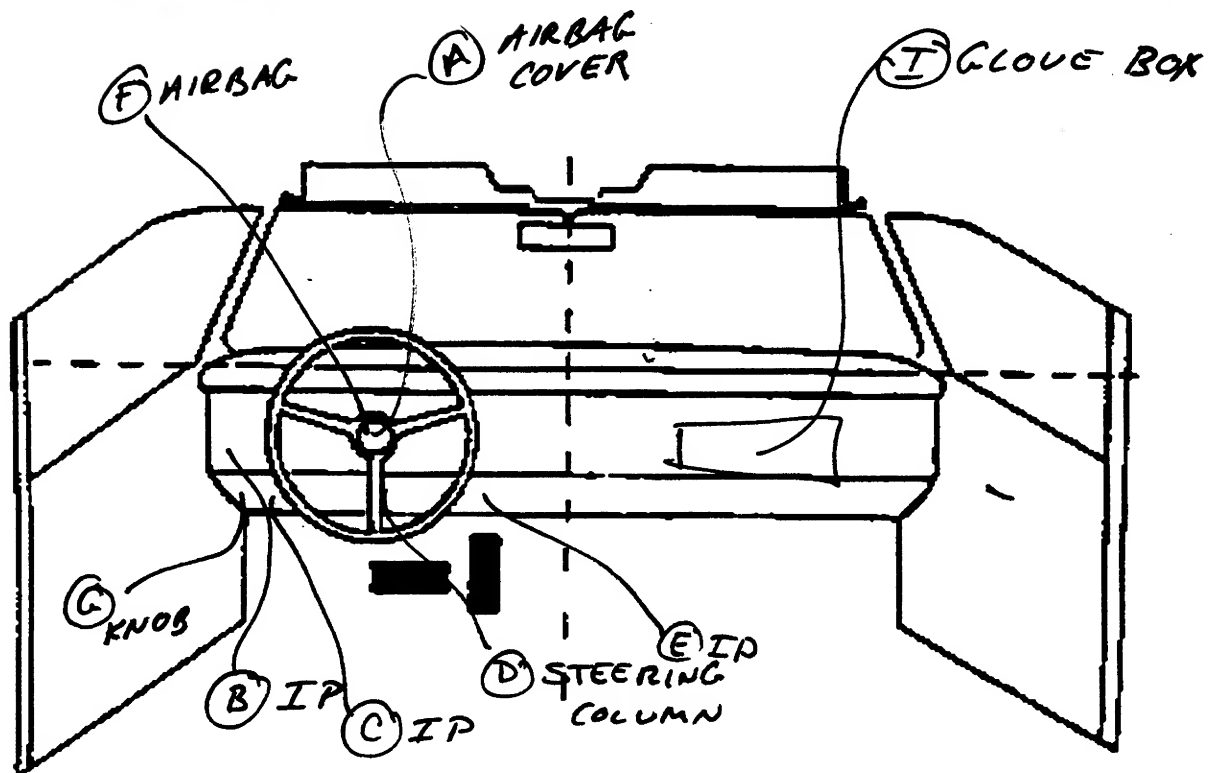
VEHICLE OCCUPANT CONTACT DIAGRAM

Contact	Interior Component Contacted	Occupant No. if Known	Body Region if Known	Supporting Physical Evidence	Confidence Level of Contact Point
A	AIRBAG COVER	1		BENT	2
B	LOWER IP	1		SCUFF 5x5cm FAR LEFT	1
C	LOWER IP	1		SCUFF 10x5cm LEFT	1
D	STEERING COLUMN	1		BROKEN PLASTIC	1
E	LOWER IP	1		SCUFF 8x2 RIGHT	1
F	AIRBAG	1		MAKEUP	1
G	KNOB ON IP	1		BROKEN	1
H	CENTER CONSOLE	2		SCUFF SKIN 7x2cm	1
I	GLOVE BOX	2		DEFORMATION	1
J	ALMIST	2		DEMY 4x2	1
